Cape Hatteras Lighthouse Relocation

One Man, Two Robotic System Make History

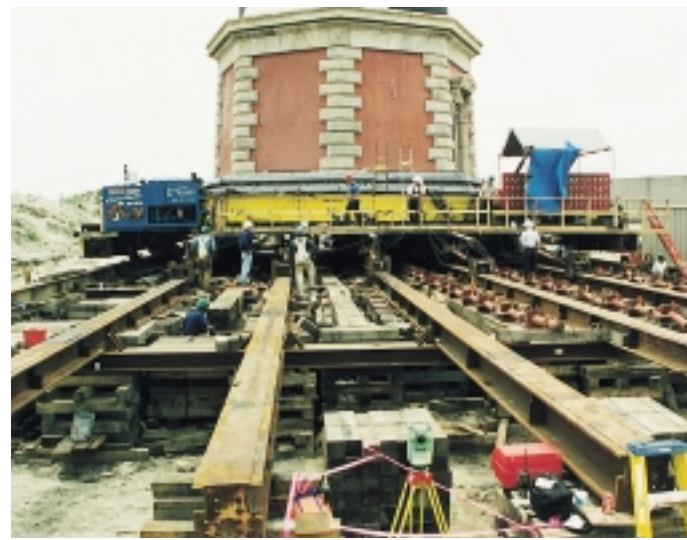
A Leica TCA1103 monitors the settlement as the lighthouse is pushed off the original wooden timbers by five hydraulic jacks.

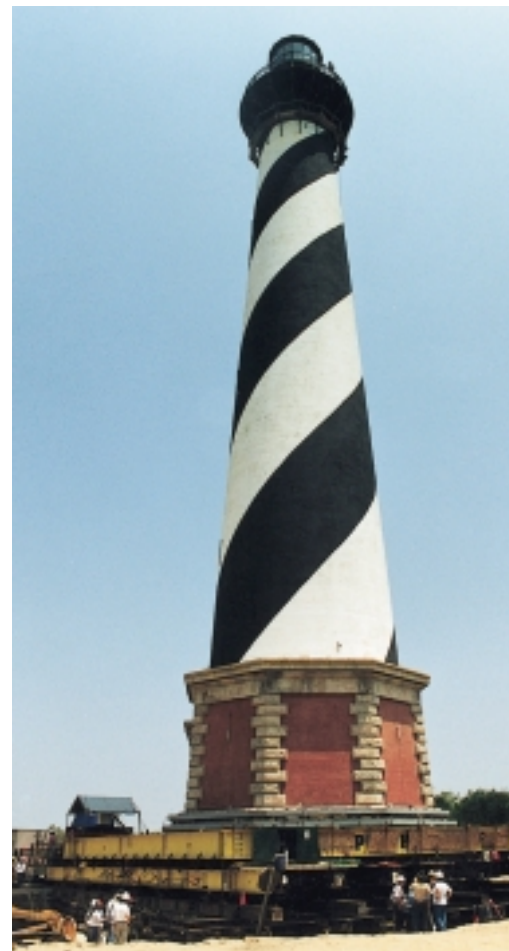
The Hatteras lighthouse on its steel base and seven track rails as it nears the new location.

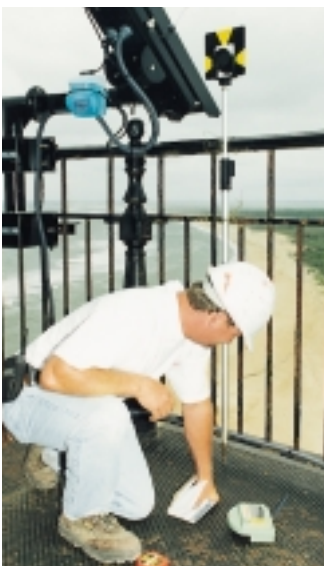
Leica prisms were mounted on the top and the base of the lighthouse and checked every day. The black box is the housing for the Internet site camera.

The riggers attached two prisms to the main shaft of the lighthouse structure: one near the bottom and one attached near the top. The riggers then cut the granite substructure and began transferring load to 100 hydraulic shoring jacks (each capable of lifting 100 tons). Once the shoring jacks were in place, the steel beams and lifting jacks would be inserted to lift the lighthouse an additional six feet.

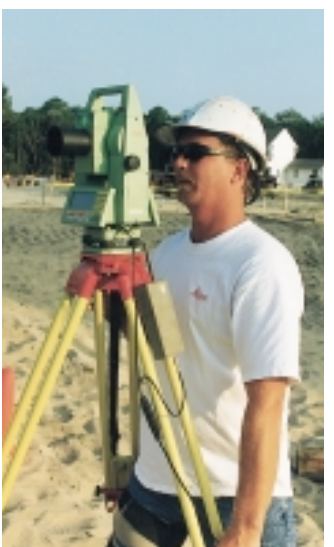
The Leica TCA 1103 was also used to monitor the settlement as the lighthouse was pushed off, and the settlement of the new foundation as the lighthouse was pushed on (0.1 ft on the old wood timbers and 0.02 ft on the new concrete foundation).

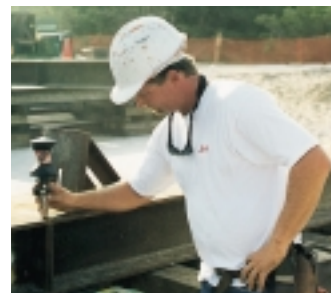
A Leica TCA1103 was used to align the rails. Centerline was held with 0.01 ft for all seven rails.

Besides the lighthouse monitoring, the surveyors needed to track the alignment of the roll beams attached to the steel rail track from the center point to the new location. On any given day, the lighthouse moved along this rail from 10 feet to 355 feet.
